# Ohio Department of Natural Resources Division of Water Fact Sheet

Fact Sheet 99-53

## Dam Safety: Embankment Instabilities

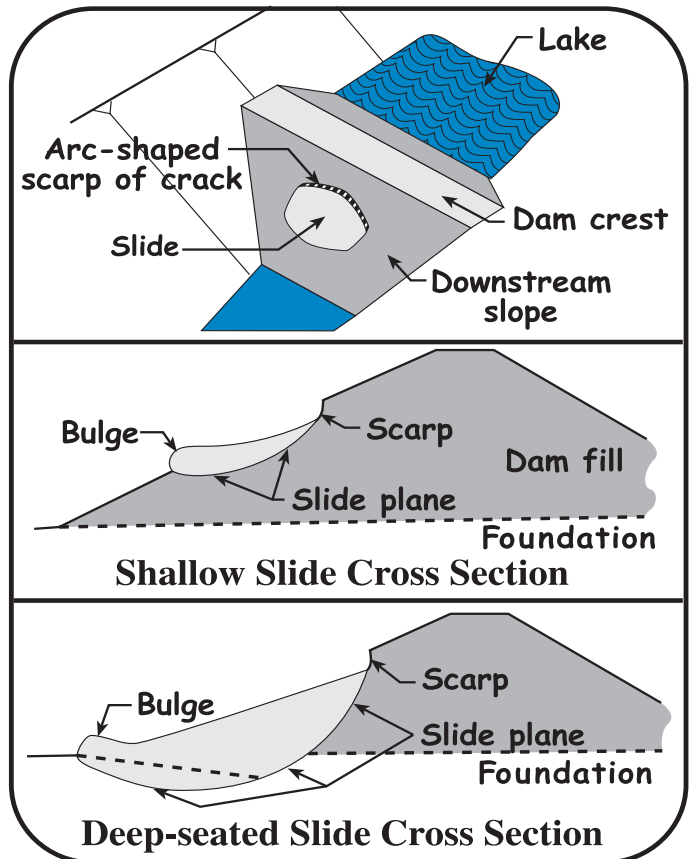
A slide in an embankment or in natural soil or rock is a mass movement of material. Some typical characteristics of a slide are an arc-shaped crack or scarp along the top and a bulge along the bottom of the slide (see drawing). Slides may develop because of poor soil compaction, the

gradient of the slope being too steep for the embankment material, seepage, sudden drawdown of the lake level, undercutting of the embankment toe, or saturation and weakening of the embankment or foundation.

Slides can be divided into two main groups: shallow and deep-seated. Shallow slides generally affect the top 2 to 3 feet of the embankment surface. Shallow slides are generally not threatening to the immediate safety of the dam and often result from wave erosion, collapsed rodent burrows, or saturated top soil. Deep-seated slides are serious, immediate threats to the safety of a dam. They can extend several feet below the surface of the embankment, even below the foundation. A massive slide can initiate the catastrophic failure of a dam. Deep-seated slides are the result of serious problems within the embankment.
