Ohio Department of Natural Resources
Division of Soil and Water Resources
Fact Sheet

Fact Sheet 99-53

Dam Safety: Embankment Instabilities

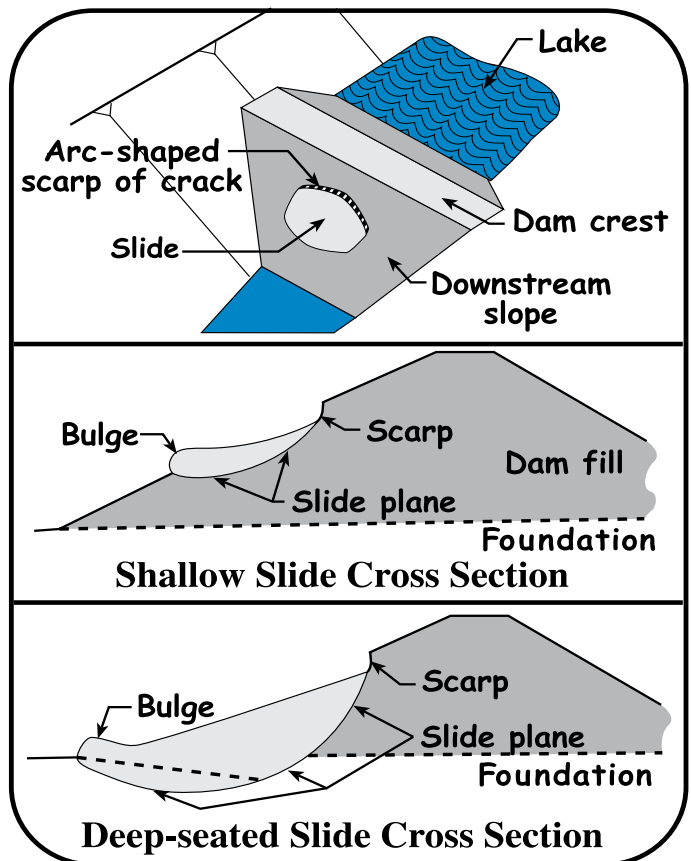
A slide in an embankment or in natural soil or rock is a mass movement of material. Some typical characteristics of a slide are an arc-shaped crack or scarp along the top and a bulge along the bottom of the slide (see drawing). Slides may develop because of poor soil compaction, the

gradient of the slope being too steep for the embankment material, seepage, sudden drawdown of the lake level, undercutting of the embankment toe, or saturation and weakening of the embankment or foundation.

Slides can be divided into two main groups: shallow and deep-seated. Shallow slides generally affect the top 2 to 3 feet of the embankment surface. Shallow slides are generally not threatening to the immediate safety of the dam and often result from wave erosion, collapsed rodent burrows, or saturated top soil. Deep-seated slides are serious, immediate threats to the safety of a dam. They can extend several feet below the surface of the embankment, even below the foundation. A massive slide can initiate the catastrophic failure of a dam. Deep-seated slides are the result of serious problems within the embankment.
