Ohio Department of Natural Resources Division of Water Fact Sheet

Fact Sheet 99-51

Dam Safety: Outlet Erosion Control Structures (Stilling Basins)

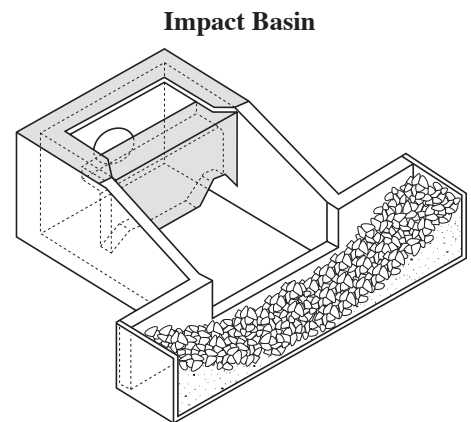
Impact Basin

A concrete impact basin is an energy dissipating device located at the outlet of the spillway in which flow

from the discharge conduit strikes a vertical hanging baffle. Discharge is directed upstream in vertical eddies by the horizontal portion of the baffle and by the floor before flowing over the endsill. Energy dissipation occurs as the discharge strikes the baffle, thus, performance is not dependent on tailwater. Most impact basins were designed by the United States Department of Agriculture, Natural Resources Conservation Service and the United States Department of Interior, Bureau of Reclamation. If any of the severe defects that are referenced in the opening paragraphs are observed, a registered professional engineer should be contacted to evaluate the stability of the outlet.

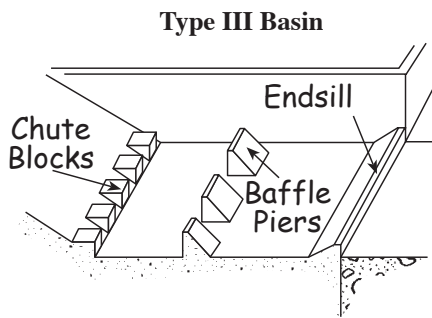
U.S. Department of Interior, Bureau of Reclamation Type II and Type III Basins

Type II and Type III basins reduce the energy of the flow discharging from the outlet of a spillway and allow the water to exit into the outlet channel at a reduced velocity. Type II energy dissipators contain chute blocks at the upstream end of the basin and a dentated (tooth-like) endsill. Baffle piers are not used in a Type II basin because of the high velocity water entering the basin.

Type III energy dissipators can be used if the entrance velocity of the water is not high. They contain baffle piers which are located on the stilling basin apron downstream of

the chute blocks. Located at the end of both the Type II and Type III basins is an endsill. The endsill may be level or sloped, and its purpose is to create the tailwater which reduces the outflow velocity. If any of the severe defects associated with concrete structures are observed, a registered professional engineer should be contacted to evaluate the stability of the basin.

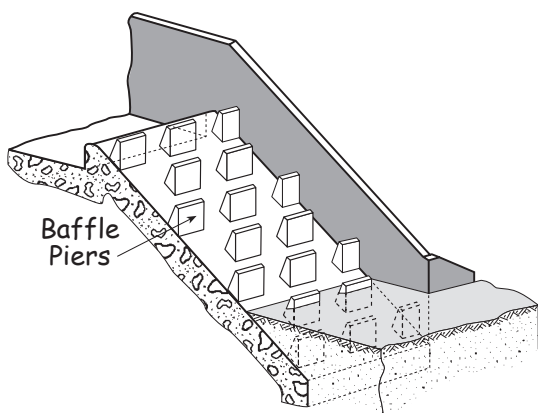
Baffled Chute Basin

Baffled chutes require no initial tailwater to be effective and are located downstream of the control section. Multiple rows of baffle piers on the chute prevent excessive acceleration of the flow and prevent the damage that occurs from a high discharge velocity. A portion of the baffled chute usually extends below the streambed elevation to prevent undermining of the chute. If any of the severe problems associated with concrete that are referenced in the opening paragraphs are observed, a registered professional engineer should be contacted to evaluate the stability of the outlet.

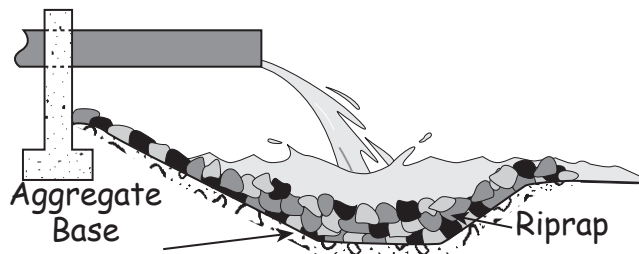
Plunge Pool

A plunge pool is an energy dissipating device located at the outlet of a spillway. Energy is dissipated as the discharge flows into the plunge pool. Plunge pools are commonly lined with rock riprap or other material to prevent excessive erosion of the pool area. Discharge from the plunge pool should be at the natural streambed elevation. Typical problems may include movement of the riprap, loss of fines from the bedding material and scour beyond the riprap and lining. If scour beneath the outlet

conduit develops, the conduit will be left unsupported and separation of the conduit joints and undermining may occur. Separation of the conduit joints and undermining may lead to failure of the spillway and ultimately the dam. A registered professional engineer should be contacted to ensure that the plunge pool is designed properly.
