Ohio Department of Natural Resources Division of Water Fact Sheet

Fact Sheet 99-52

Dam Safety: Upstream Slope Protection

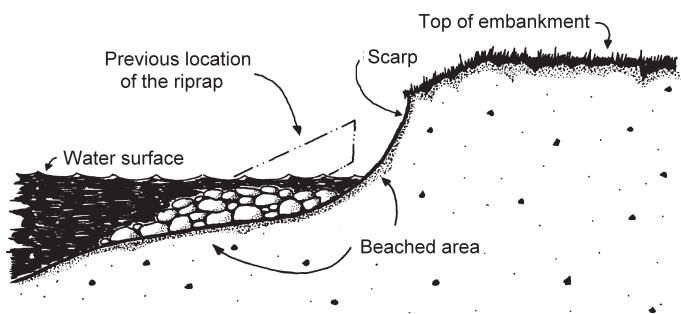
Figure 1 - Beaching

The repeated action of waves striking the embankment surface erodes fill material and displaces it farther down the slope, creating a “beach.” The amount of erosion depends on the predominant wind direction, the orientation of the dam, the steepness of the slope, water level fluctuations, boating activities, and other factors. Further erosion can lead to cracking and sloughing of the slope which can extend into the crest, reducing its width. When erosion occurs and beaching develops on the upstream slope of a dam, repairs should be made as soon as possible. However, an erosion scarp less than 1 foot high may be stable and not require repair.

Slope protection is usually needed to protect the upstream slope against erosion due to wave action. Without proper slope protection, a serious erosion problem known as “beaching” can develop on the upstream slope.

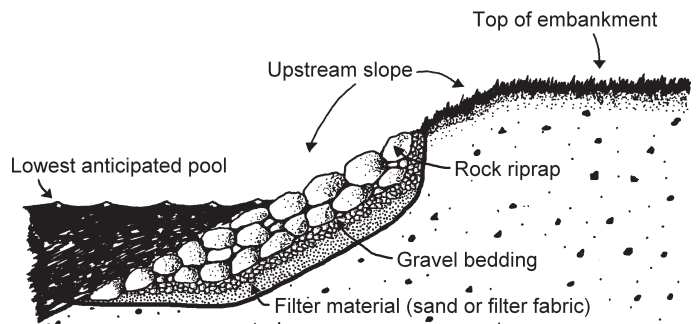
Figure 2 - Rock Riprap

Rock riprap consists of a heterogeneous mixture of irregular shaped rocks placed over gravel bedding and a sand filter or geotextile fabric. The smaller rocks help to fill the spaces between the larger pieces forming an interlocking mass. The filter prevents soil particles on the embankment surface from being washed out through the spaces (or voids) between the rocks. The maximum rock

size and weight must be large enough to break up the energy of the maximum anticipated wave action and hold the smaller stones in place. If the rock size is too small, it will eventually be displaced and washed away by wave action. If the riprap is sparse or if the filter or bedding material is too small, the filter material will wash out easily, allowing the embankment material to erode. Once the erosion has started, beaching will develop if remedial measures are not taken. Technical Release No. 69 developed by the USDA, Natural Resources Conservation Service can be used to help design engineers develop a preliminary or detailed design for riprap slope protection.

The dam owner should expect some deterioration (weathering) of riprap. Freezing and thawing, wetting and drying, abrasive wave action, and other natural processes will eventually break down the riprap. Its useful life varies with the characteristics of the stone used. Stone for riprap should be rock that is dense and well cemented. In Ohio, glacial cobbles or boulders, most limestone, and a few types of sandstone are acceptable for riprap. Most sandstones and shales found in Ohio do not provide long-term protection. Due to the high initial cost of rock riprap, its durability should be determined by appropriate testing procedures prior to installation. Vegetative growth within the slope protection is undesirable because it can displace stone and disturb the filter material. Heavy undergrowth prevents an adequate inspection of the upstream slope and may hide potential problems. For additional information, see the “Trees and Brush” fact sheet.

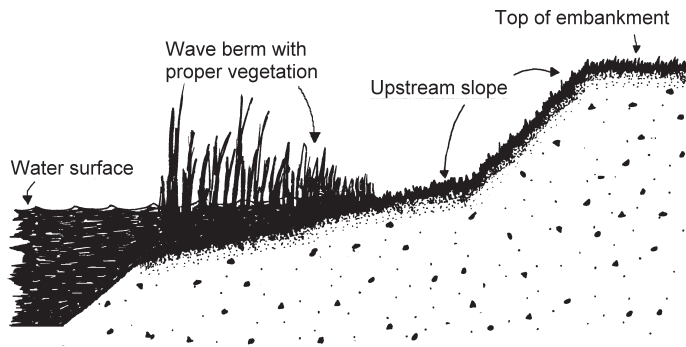
Figure 3 - Vegetated wave berm

Vegetated wave berms dissipate wave energy and protect the slope from erosion. Berms are constructed on the upstream slope at the normal pool level and should be no less than 20 feet wide. This method of slope protection will not work well where the water surface fluctuates regularly from normal pool. If improper or sparse vegetation is present, the wave berm may not adequately dissipate the wave energy, allowing erosion and beaching to develop on the upstream slope. Technical Release No. 56 developed by the USDA, Natural Resources Conservation Service provides design and layout information.

The vegetation on the wave berm should be monitored regularly to verify adequate growth. Sufficient funds should be allocated for the regular maintenance of the vegetation. Severe erosion or reoccurring problems may require a registered professional engineer to design a more effective slope protection.

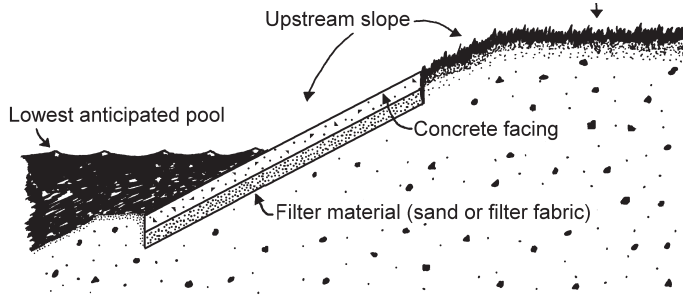
Figure 4 - Concrete facing

Concrete facing can be used if severe wave action is anticipated, however, settlement of the embankment must be insignificant to insure adequate support for the concrete facing. A properly designed and constructed concrete facing can be expensive. This slope protection should extend several feet above and below the normal pool level. It should terminate on a berm or against a concrete curb or header. Granular filter or filter fabric (geotextile) is required under the concrete facing to help reduce the risk of undermining.

As with any type of slope protection, problems will develop if the concrete facing has not been properly designed or installed. Concrete facing often fails because the wave action washes soil particles from beneath the slabs through joints and cracks. This process is known as undermining, which will continue until large voids are created. Detection of voids is difficult because the voids are hidden. Failure of the concrete facing may be sudden and extensive. Concrete facing should be monitored for cracks and open joints. Open joints should be sealed with plastic fillers and cracks should be grouted and sealed. For additional information, see the “Problems with Concrete Materials” fact sheet.
