# Ohio Department of Natural Resources Division of Soil and Water Resources Fact Sheet

Fact Sheet 99-52

## Dam Safety: Upstream Slope Protection

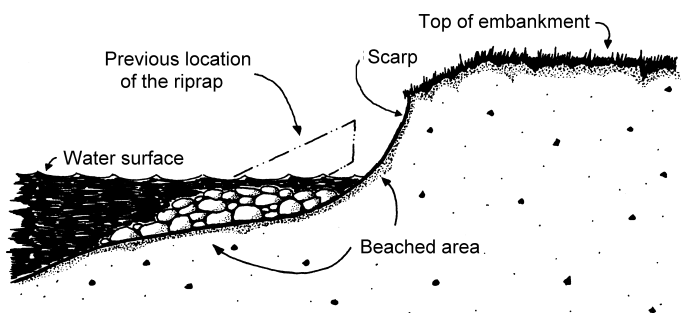
Figure 1 - Beaching

The repeated action of waves striking the embankment surface erodes fill material and displaces it farther down the slope, creating a “beach.” The amount of erosion depends on the predominant wind direction, the orientation of the dam, the steepness of the slope, water level fluctuations, boating activities, and other factors. Further erosion can lead to cracking and sloughing of the slope which can extend into the crest, reducing its width. When erosion occurs and beaching develops on the upstream slope of a dam, repairs should be made as soon as possible. However, an erosion scarp less than 1 foot high may be stable and not require repair.

**S**lope protection is usually needed to protect the upstream slope against erosion due to wave action. Without proper slope protection, a serious erosion problem known as “beaching” can develop on the upstream slope.

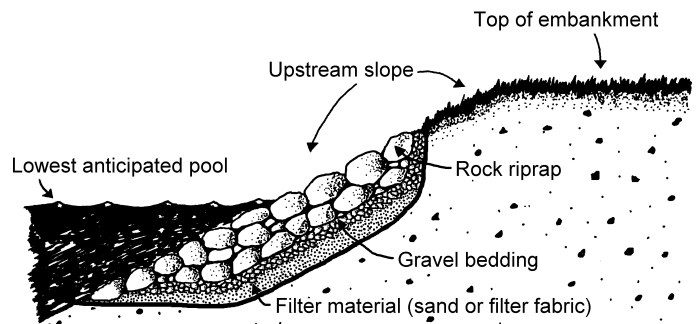
Figure 2 - Rock Riprap

Rock riprap consists of a heterogeneous mixture of irregular shaped rocks placed over gravel bedding and a sand filter or geotextile fabric. The smaller rocks help to fill the spaces between the larger pieces forming an interlocking mass. The filter prevents soil particles on the embankment surface from being washed out through the spaces (or voids) between the rocks. The maximum rock

size and weight must be large enough to break up the energy of the maximum anticipated wave action and hold the smaller stones in place. If the rock size is too small, it will eventually be displaced and washed away by wave action. If the riprap is sparse or if the filter or bedding material is too small, the filter material will wash out easily, allowing the embankment material to erode. Once the erosion has started, beaching will develop if remedial measures are not taken. Technical Release No. 69 developed by the USDA, Natural Resources Conservation Service can be used to help design engineers develop a preliminary or detailed design for riprap slope protection.

The dam owner should expect some deterioration (weathering) of riprap. Freezing and thawing, wetting and drying, abrasive wave action, and other natural processes will eventually break down the riprap. Its useful life varies with the characteristics of the stone used. Stone for riprap should be rock that is dense and well cemented. In Ohio, glacial cobbles or boulders, most limestone, and a few types of sandstone are acceptable for riprap. Most sandstones and shales found in Ohio do not provide long-term protection. Due to the high initial cost of rock riprap, its durability should be determined by appropriate testing procedures prior to installation. Vegetative growth within the slope protection is undesirable because it can displace stone and disturb the filter material. Heavy undergrowth prevents an adequate inspection of the upstream slope and may hide potential problems. For additional information, see the “Trees and Brush” fact sheet.

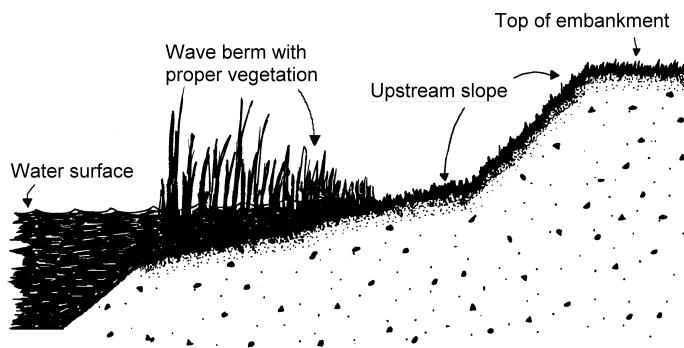
Figure 3 - Vegetated wave berm

Vegetated wave berms dissipate wave energy and protect the slope from erosion. Berms are constructed on the upstream slope at the normal pool level and should be no less than 20 feet wide. This method of slope protection will not work well where the water surface fluctuates regularly from normal pool. If improper or sparse vegetation is present, the wave berm may not adequately dissipate the wave energy, allowing erosion and beaching to develop on the upstream slope. Technical Release No. 56 developed by the USDA, Natural Resources Conservation Service provides design and layout information.

The vegetation on the wave berm should be monitored regularly to verify adequate growth. Sufficient funds should be allocated for the regular maintenance of the vegetation. Severe erosion or reoccurring problems may require a registered professional engineer to design a more effective slope protection.

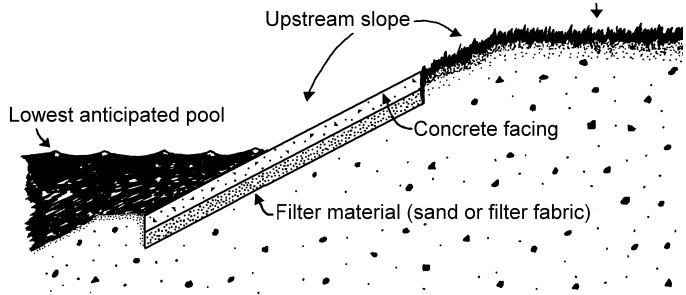
Figure 4 - Concrete facing

Concrete facing can be used if severe wave action is anticipated, however, settlement of the embankment must be insignificant to insure adequate support for the concrete facing. A properly designed and constructed concrete facing can be expensive. This slope protection should extend several feet above and below the normal pool level. It should terminate on a berm or against a concrete curb or header. Granular filter or filter fabric (geotextile) is required under the concrete facing to help reduce the risk of undermining.

As with any type of slope protection, problems will develop if the concrete facing has not been properly designed or installed. Concrete facing often fails because the wave action washes soil particles from beneath the slabs through joints and cracks. This process is known as undermining, which will continue until large voids are created. Detection of voids is difficult because the voids are hidden. Failure of the concrete facing may be sudden and extensive. Concrete facing should be monitored for cracks and open joints. Open joints should be sealed with plastic fillers and cracks should be grouted and sealed. For additional information, see the “Problems with Concrete Materials” fact sheet.
