Ohio Department of Natural Resources
Division of Soil and Water Resources
Fact Sheet

Fact Sheet 99-57

Dam Safety: Problems with Metal Materials

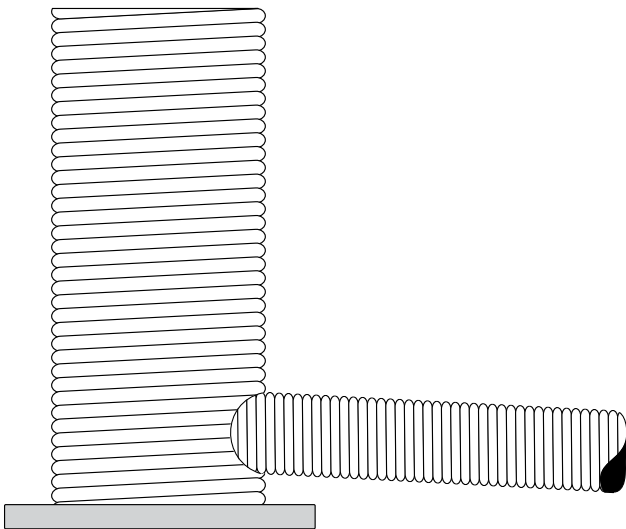
Figure 1 – Example of a corrugated metal pipe and riser spillway.

Corrosion is a common problem for spillway conduits and other metal appurtenances. Corrosion is the deterioration or breakdown of metal because of a reaction with its environment. Exposure to moisture, acidic conditions, or salt will accelerate the corrosion process. Acid runoff from strip-mined areas will cause rapid corrosion of metal conduits. In these areas, conduits made of less corrodible materials such as concrete or plastic should be used. Soil types also factor into the amount of corrosion. Clayey soils can be more corrosive than sandy soils since they are poorly drained and poorly aerated. Silts are somewhere in between clays and sands. Some examples of metal conduits include ductile iron, smooth steel, and corrugated metal. Corrugated metal pipe is not recommended for use in dams since the service life for corrugated metal is only 25 to 30 years, whereas the life expectancy for dams is much longer. In areas of acidic water, the service life can be much less. Therefore, corrugated metal spillway conduits typically need to be repaired or replaced early in the dam's design life, which can be very expensive.
